While often overlooked, the maintenance costs of an aircraft APU will be equal to as much as \$100 per flight hour unless managed well. The technical issues affecting APU operation, their management, and maintenance drivers and requirements are examined.

APU maintenance & management

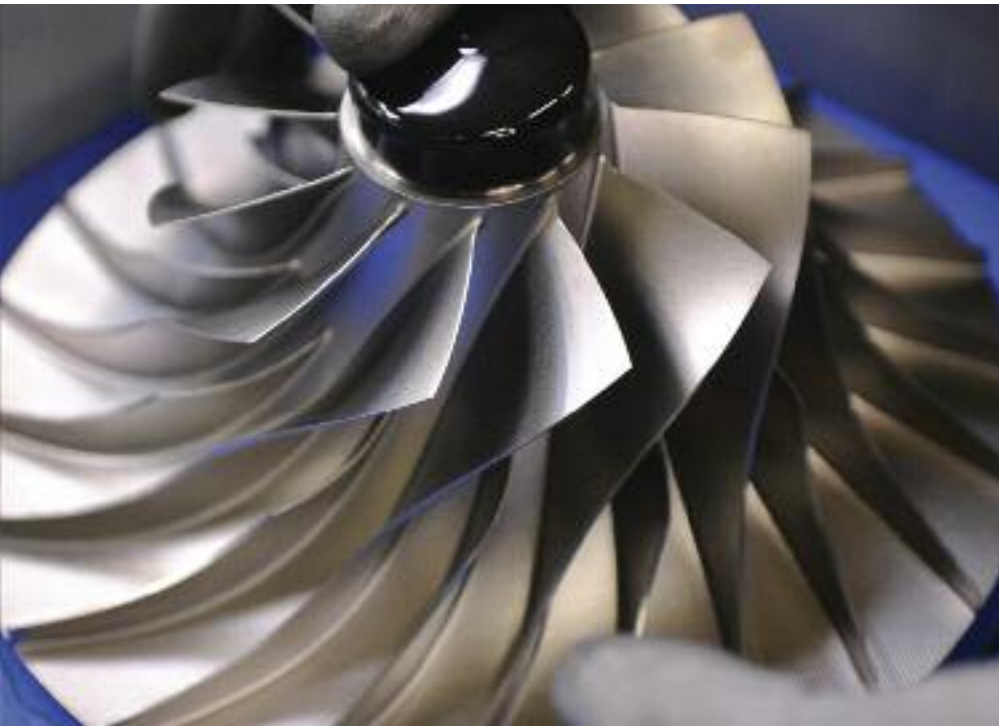
The centrifugal compressor of a radial-configured APU is a core component. Deterioration of this and the turbine disk stages are key drivers of removal for shop visit maintenance.
